# Laser Marking Machine Common Fault Repair

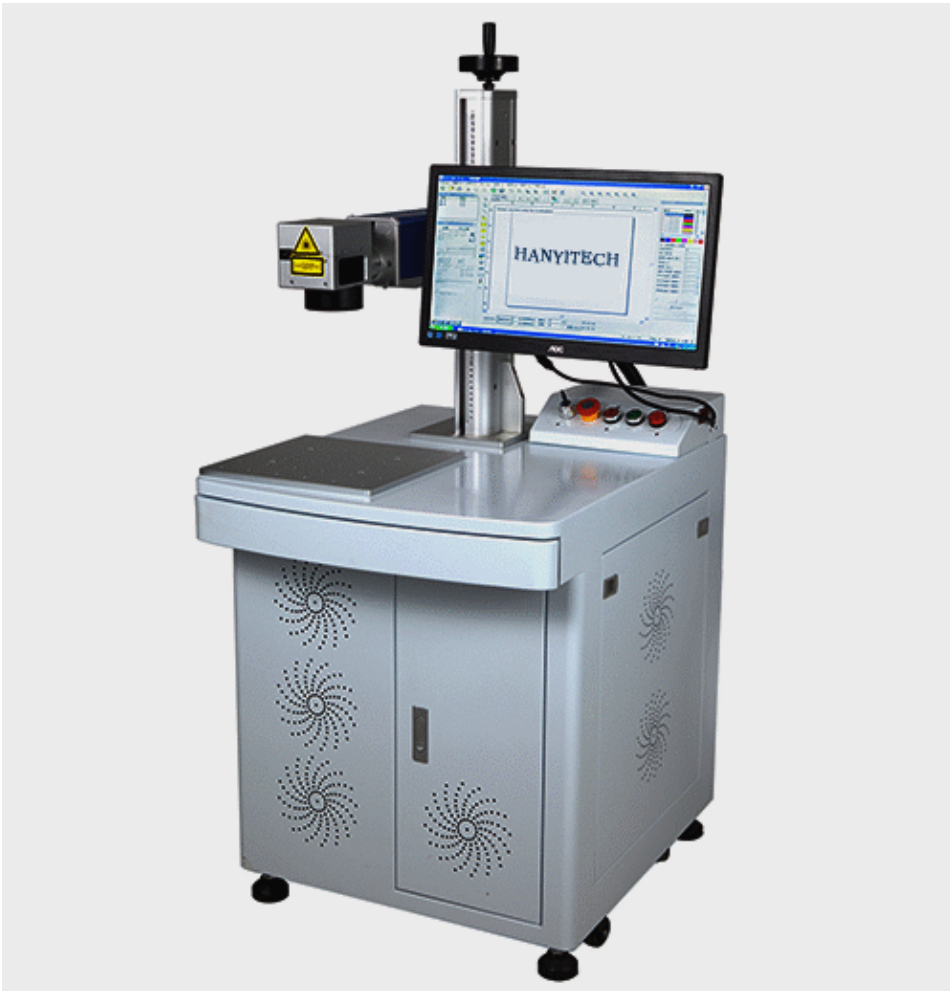
Equipment in marking varying text depth of the phenomenon manifested as the middle shallow two-shallow, the middle deep two shallow.

Because the workpiece's processing surface is circular, the laser to the workpiece surface of the distance between the points is not equal. Due to various reasons (vibration, tooling wear or fixed bolt loosening), the distance from the lens to the workpiece changes. You need to adjust the laser's position according to the equipment on the focal length adjustment direction fine-tuning to find the best effect. Note that each adjustment should not be too large, make a good record of the effect after each adjustment to find out the changing trend to be fast and accurate. Otherwise, it is easy to adjust to the chaos and waste time.
