# Laser Marking Machine Common Fault Repair

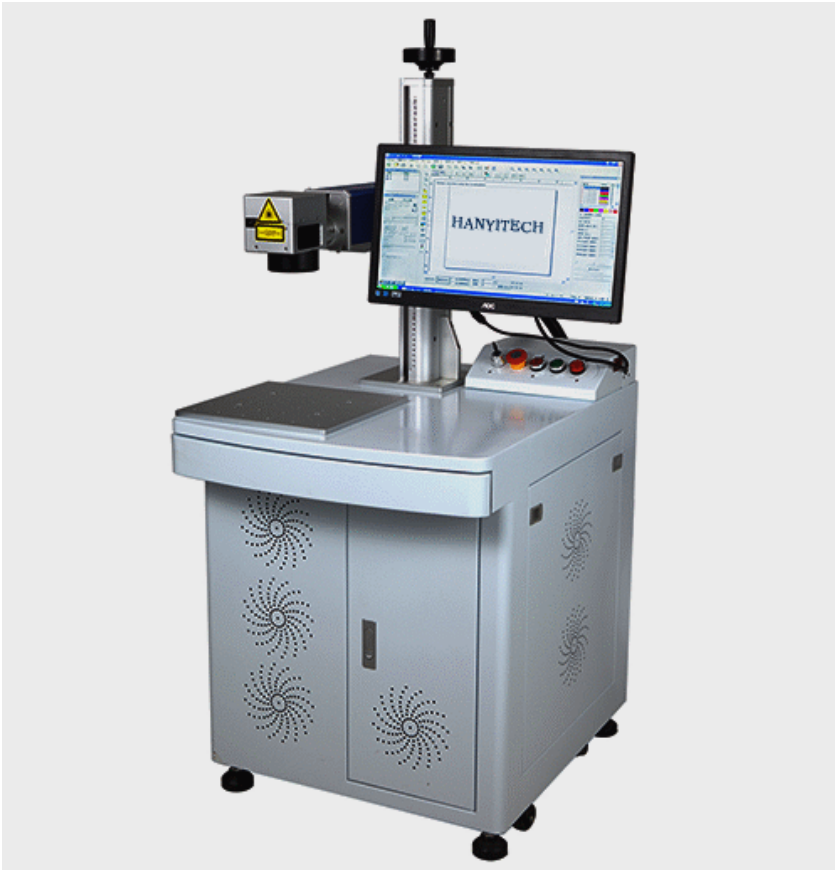
Equipment in marking varying text depth of the phenomenon manifested as the middle shallow two-deep or the middle deep two shallow.

Because the workpiece's processing surface is circular, the laser to the workpiece surface of the distance between the points is not equal. Due to various reasons (vibration, tooling wear or fixed bolt loosening, etc.), the distance from the lens to the workpiece changes. You need to adjust the laser's position according to the equipment on the focal length adjustment direction fine-tuning to find the best effect. Note that each adjustment should not be too large, make a good record of the effect after each adjustment to find out the changing trend to be fast and accurate. Otherwise, it is easy to adjust to the chaos and waste time.
