Laser Marking Machine Common Fault Repair

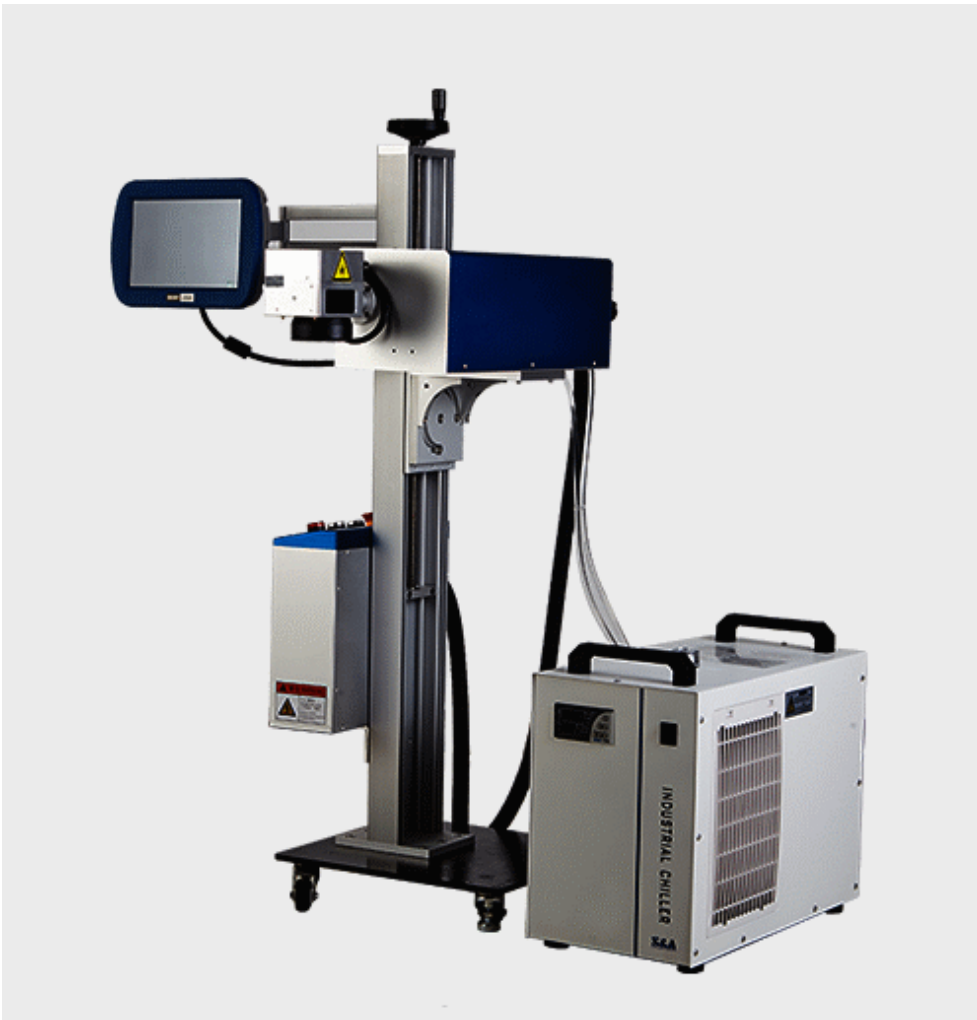
A laser marking machine is a piece of relatively precise equipment, mainly used to engrave product information on the stainless steel shell of the product. The working process is as follows: the workpiece is placed on the workpiece trolley at the right position, while the barcode scanner sweeps in the workpiece information, then the computer prompts the operator to close the safety gate, while the workpiece is fixed and reaches the predetermined position, then the computer controls the laser to fire the laser and engrave the workpiece information on the workpiece. When the marking is finished, the laser output is stopped, the workpiece and the safety gate return to the original position, and the scanner sweeps the barcode to confirm the marking is completed. Laser marking machine is mainly composed of an Nd: YAG laser and control equipment, the main component of the laser is the laser head, the laser head is an internal cross-sectional oval cavity, the internal cavity surface is a gold reflective coating used to reflect the krypton flashlight as the driving light.

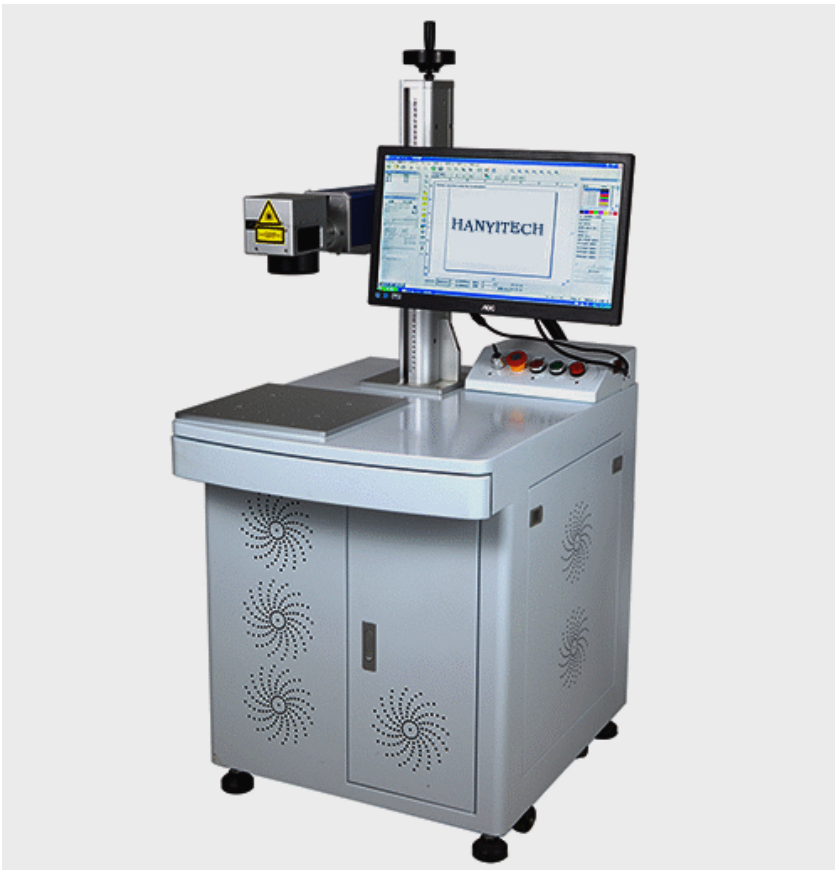
Because the workpiece's processing surface is circular, the laser to the workpiece surface of the distance between the points is not equal. Due to various reasons (vibration, tooling wear or fixed bolt loosening, etc.), the distance from the lens to the workpiece changes. You need to adjust the laser's position according to the equipment on the focal length adjustment direction fine-tuning to find the best effect. Note that each adjustment should not be too large, make a good record of the effect after each adjustment to find out the changing trend to be fast and accurate. Otherwise, it is easy to adjust to the chaos and waste time.
