Laser Marking Machine Common Fault Repair

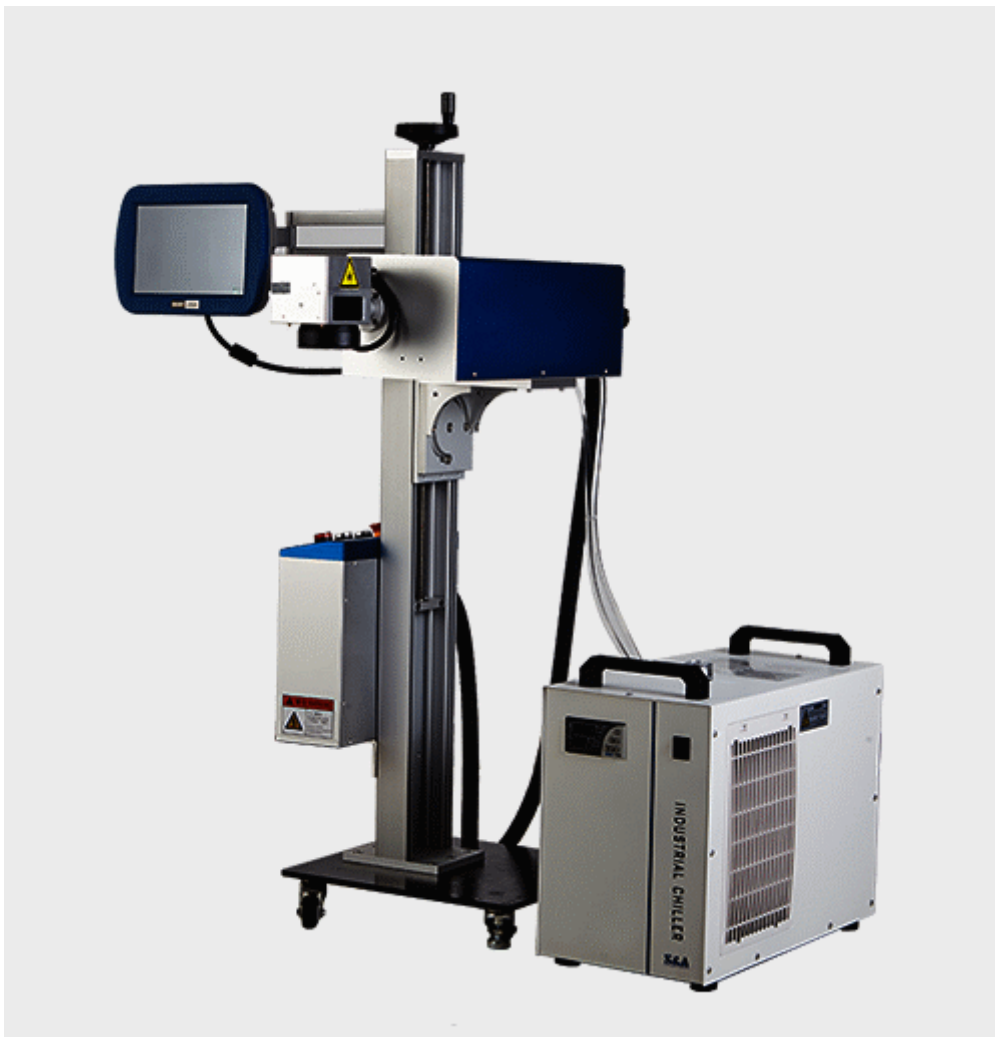
A laser marking machine is a piece of relatively precise equipment, mainly used to engrave product information on the stainless steel shell of the product. The working process is as follows: the workpiece is placed on the workpiece trolley at the right position, while the barcode scanner sweeps in the workpiece information, then the computer prompts the operator to close the safety gate, while the workpiece is moved and reaches the predetermined position, then the computer controls the laser to fire the laser and engraves the workpiece information on the workpiece. When the marking is finished, the laser output is stopped, the workpiece and the safety gate return to the original position, and the scanner sweeps the barcode to complete the marking is completed. Laser marking machine is mainly composed of an Nd: YAG laser and control equipment, the main component of the laser is the laser head, the laser head is an internal cross-sectional oval cavity, the internal cavity surface is a gold reflective coating used to reflect the krypton flashlight driving light.

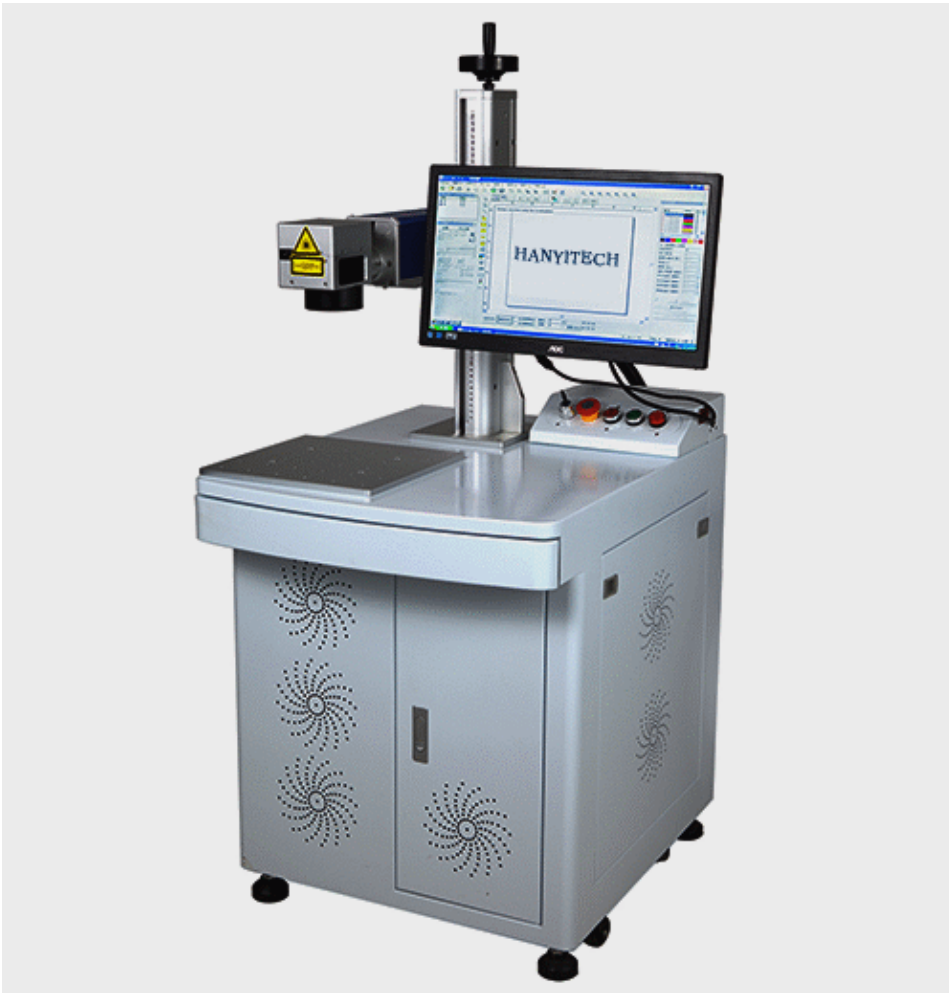
Because the workpiece's processing surface is circular, the laser to the workpiece surface of the distance between the points is not equal. Due to various reasons (vibration, tooling wear or fixed bolt loosening), the distance from the lens to the workpiece changes. You need to adjust the laser's position according to the equipment on the focal length adjustment direction fine-tuning to find the best effect. Note that each adjustment should not be too large, make a good record of the effect after each adjustment to find out the changing trend to be fast and accurate. Otherwise, it is easy to adjust to the chaos and waste time.
