Laser Marking Machine Common Fault Repair

Detail Introduction :

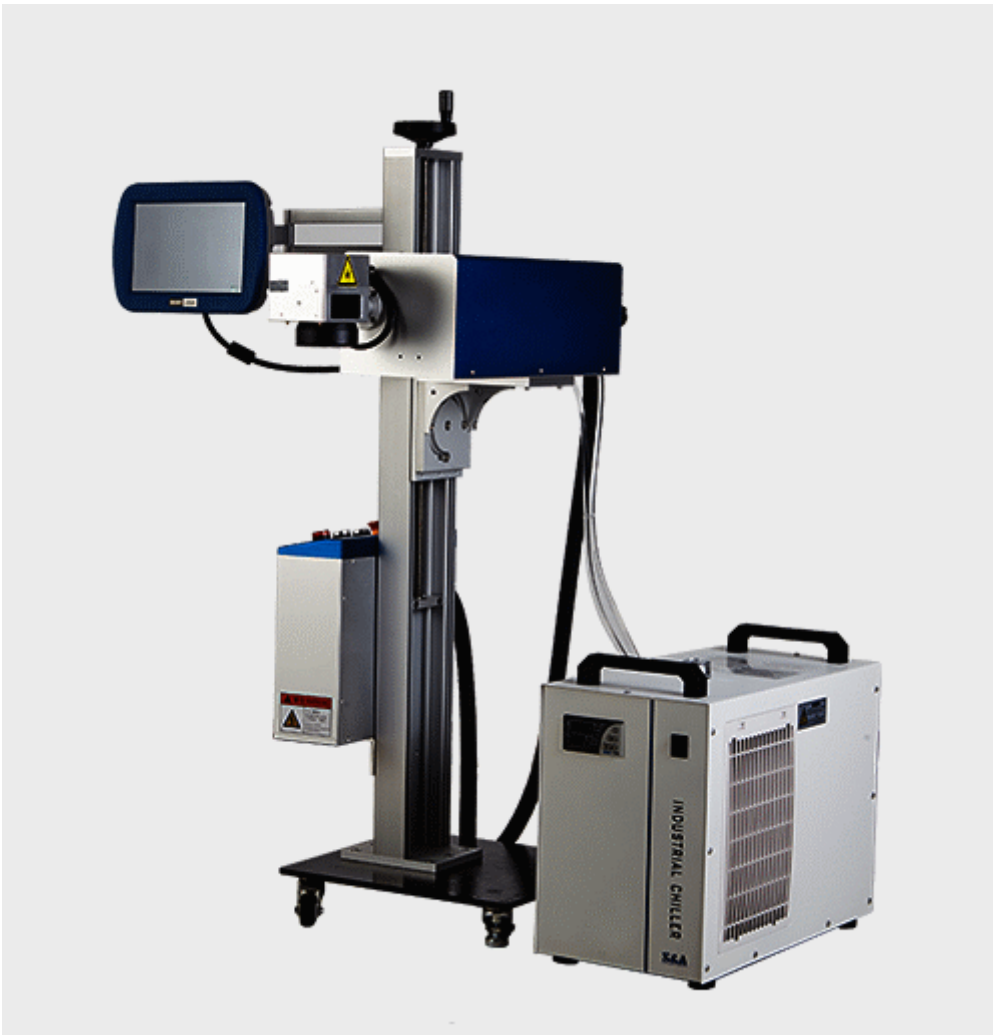
A laser marking machine is a piece of relatively precise equipment, mainly used to engrave product information on the stainless steel shell of the product. The working process is as follows: the workpiece is placed on the workpiece trolley at the right position, while the barcode scanner sweeps in the workpiece information, then the computer prompts the operator to close the safety gate, while the workpiece is moved and reaches the predetermined position, then the computer controls the laser to fire the laser and engraves the workpiece information on the workpiece. When the marking is finished, the laser output is stopped, the workpiece and the safety gate return to the original position, and the scanner sweeps the barcode to complete the marking is completed. Laser marking machine is mainly composed of an Nd: YAG laser and control equipment, the main component of the laser is the laser head, the laser head is an internal cross-sectional oval cavity, the internal cavity surface is a gold reflective coating used to reflect the krypton flashlight driving light.
